<b>HYUNDAI</b> <b>Technical Service Bulletin</b>	<b>GROUP</b> <b>RECALL</b>	<b>NUMBER</b> <b>18-01-005</b>
	<b>DATE</b> <b>JANUARY, 2018</b>	<b>MODEL(S)</b> <b>Elantra (MD/UD)</b> <b>Elantra Coupe (JK)</b> <b>Elantra GT (GD)</b>
<b>SUBJECT:</b> 2013-2014 ELANTRA (MD/UD, JK, GD) BRAKE PEDAL STOPPER REPLACEMENT (RECALL CAMPAIGN 170)

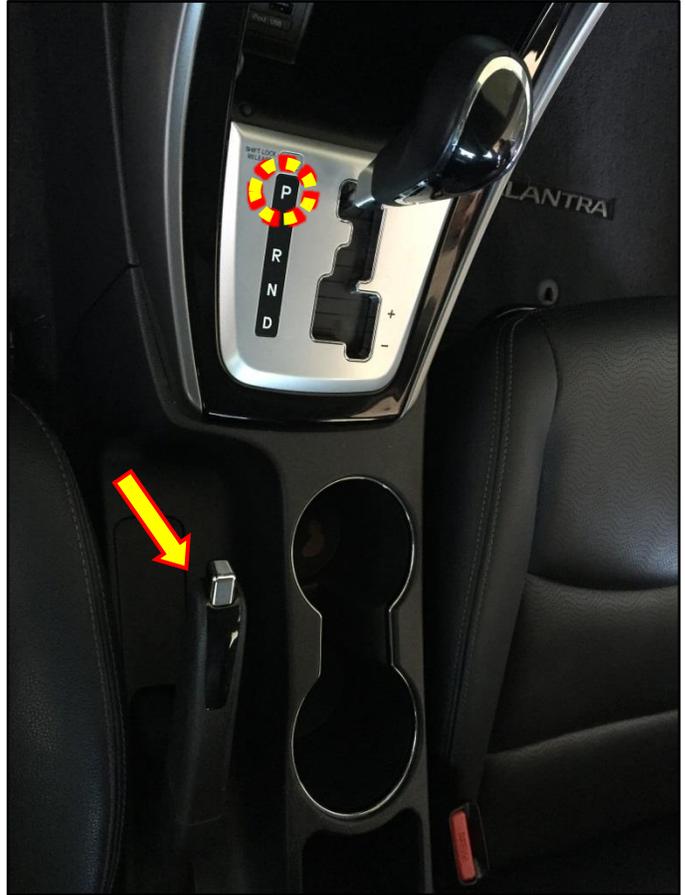
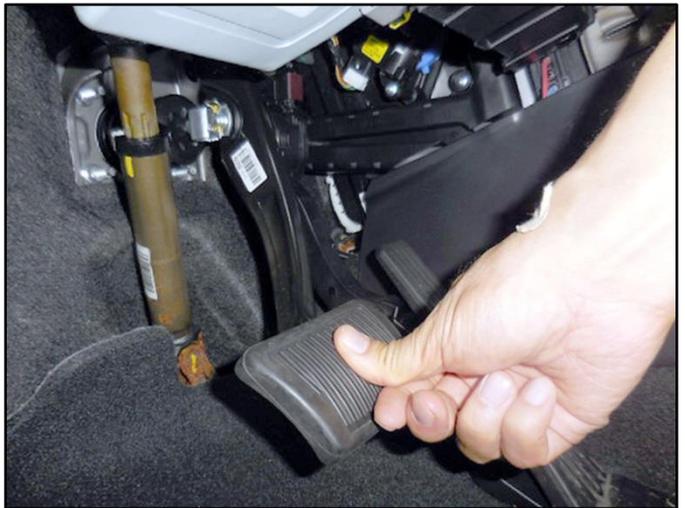
4. The stopper (A) is mounted on the brake pedal, in-line with the stop lamp switch.

1. Confirm that the shift lever is in Park (P) for automatic transmission or in Neutral (N) for manual transmission.
2. Apply the parking brake and start the engine.
3. Press and hold the brake pedal to access the stopper.
